Navajo Abandoned Uranium Mine

Site Screen Report

NA-0511 AUM Site

August 2010

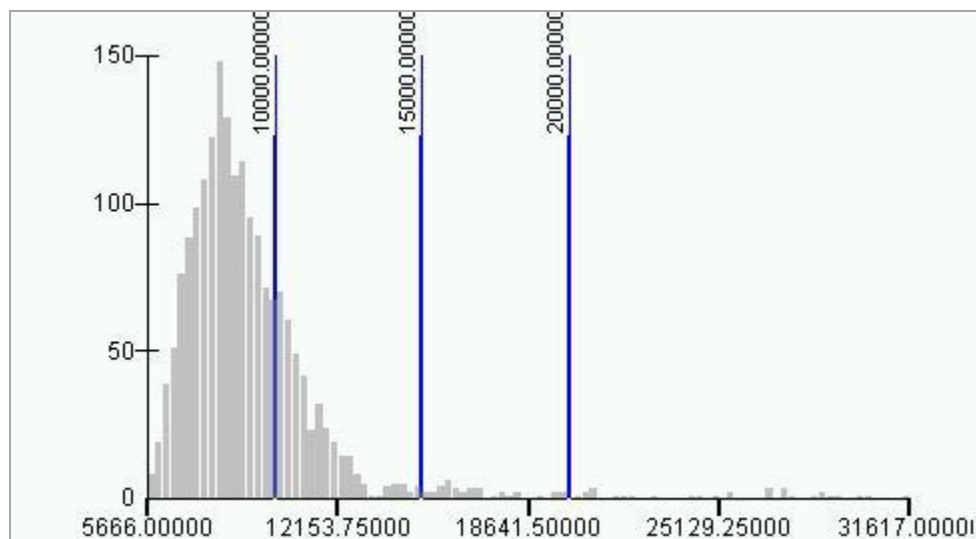
The following chart and statistics were generated by ESRI ArcGIS 9.3.1, and show the general distribution of the site gamma radiation measurements. The horizontal X axis represents the gamma radiation reading levels in cpm (lowest levels to the left). The vertical Y axis represents the frequency of each gamma radiation level.

Count:	1878
Minimum:	5666.00000
Maximum:	31617.00000
Sum:	17353240.00000
Mean:	9240.27689
Median:	8651.00000
Standard Deviation:	2861.25522

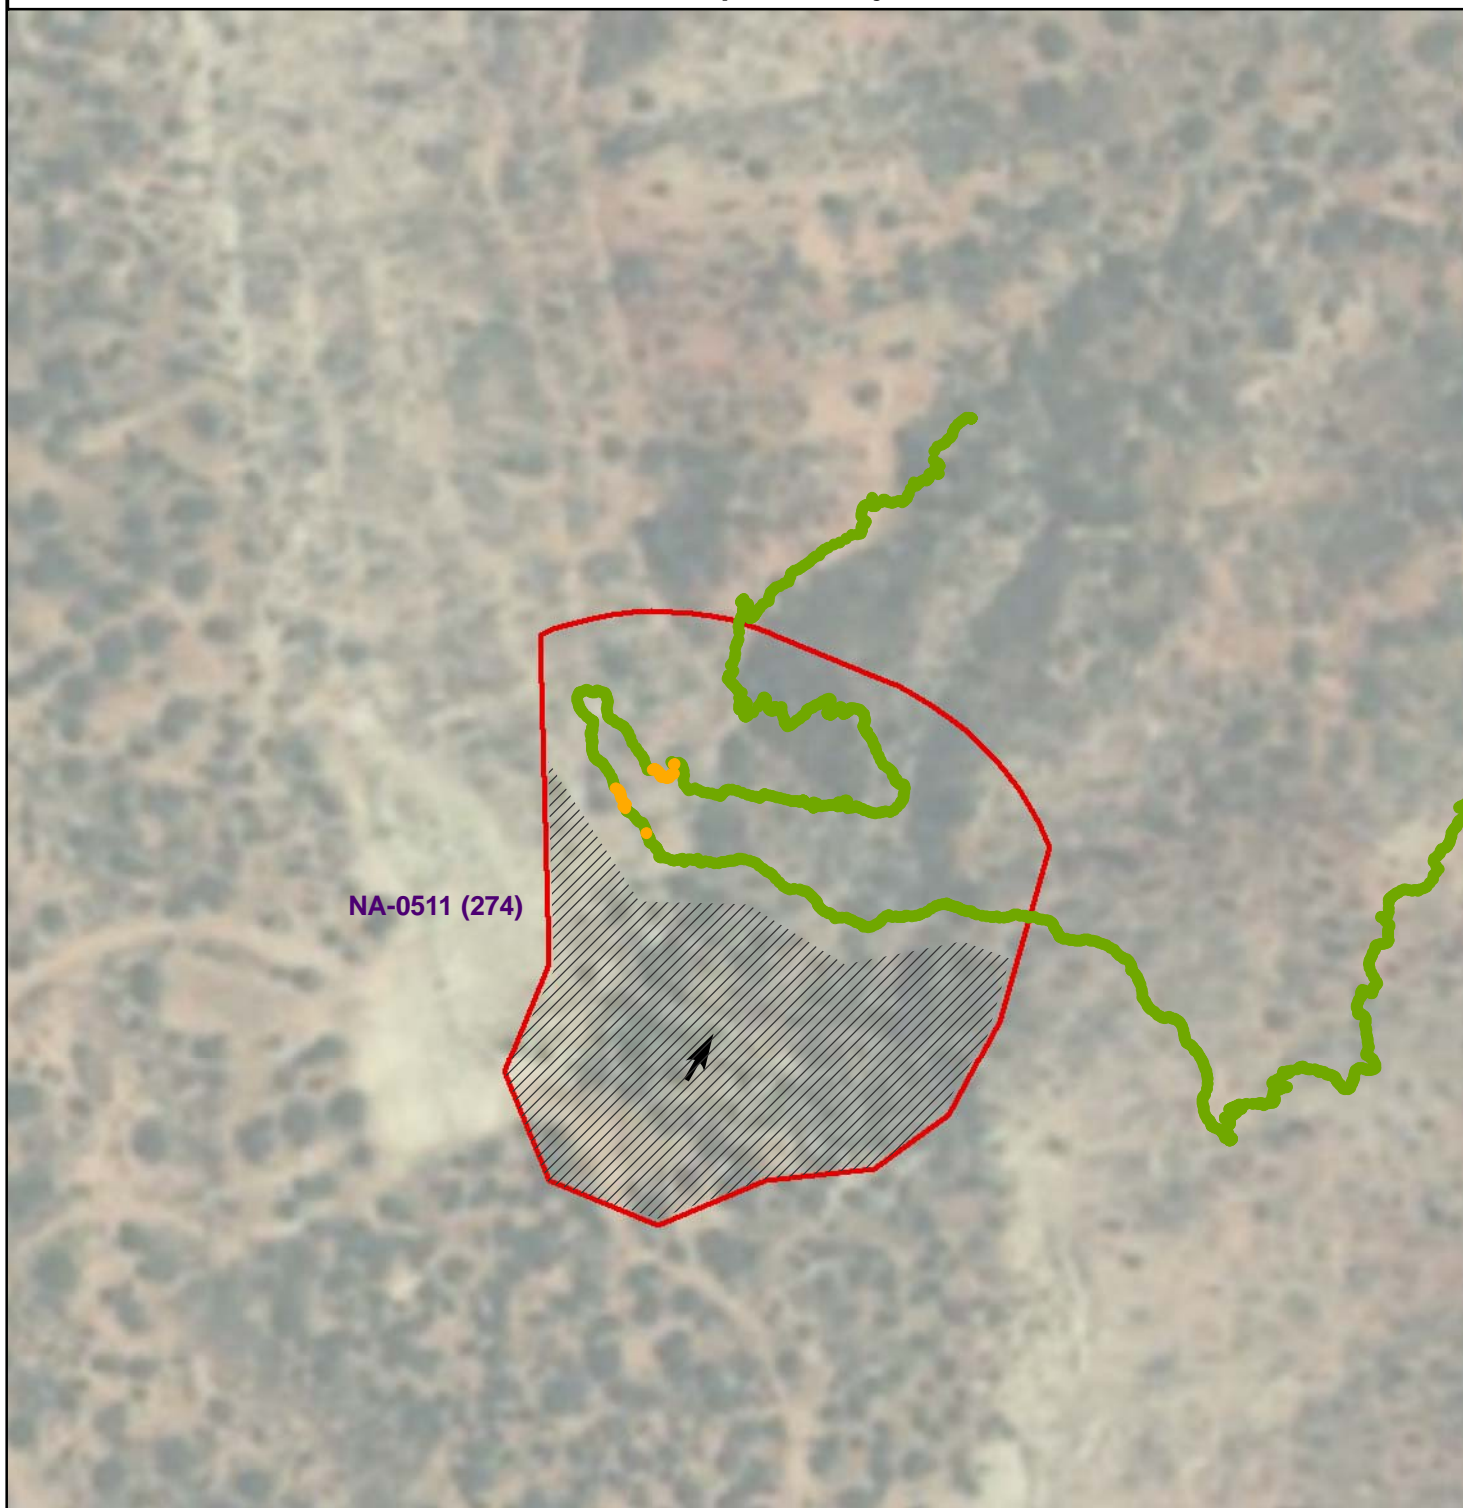
**Figure 1 - Gamma Radiation Measurements, Above Two Times Background
NA-0511 (274)
Sweetwater Chapter, Navajo Nation**

A total of 1,878 gamma radiation measurements were collected from the mine site, ranging from 5,666 cpm to 31,617 cpm. Measurements collected in the vicinity of the waste debris were found at levels up to approximately 30,000 cpm, the drainage below the waste rock was consistent with background levels. The measurements are represented in Figures 1 and 2.
